Asbestos Assessor:	Agon Enviro	Asbestos Status:	No ACM Detected - Consult	Overall Risk Rating:	0 - Not Applicable
--------------------	-------------	------------------	---------------------------	----------------------	--------------------

EPENARRA HEALTH CENTRE-WUTUNUGURRA 02022

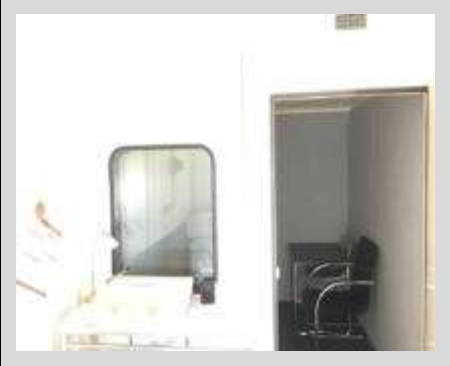
Location Details		Material Details		Results / Management Details		Photographs
ID/Primary Location:	2564 - 02 AGI Hearing Booth	Material Type:	-	Status of ACM:	-

Elevation:	Ground Floor	Quantity:	1	Sample ID:		
Position Installed:	-	Condition:	-	Sample Result:	-	
Secondary Location:	-	Friability:	-	Risk Rating:		
Urgent Action Required:	No	Surface Treatment:	-	Recommendation:	-	
Comments:	No asbestos or ACM visible upon inspection.

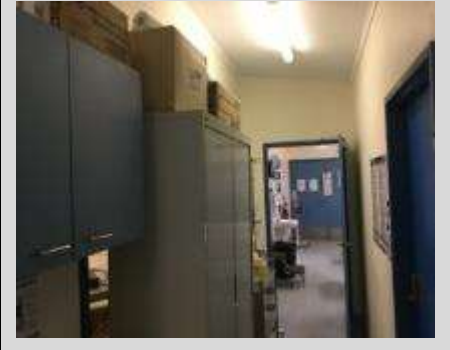
Location Details		Material Details		Results / Management Details		Photographs
ID/Primary Location:	2565 - Main Building	Material Type:	-	Status of ACM:	-

Elevation:	Ground Floor	Quantity:	1	Sample ID:		
Position Installed:	-	Condition:	-	Sample Result:	-	
Secondary Location:	-	Friability:	-	Risk Rating:		
Urgent Action Required:	No	Surface Treatment:	-	Recommendation:	-	
Comments:	No asbestos or ACM visible upon inspection.
